The M1 and White Lady Snow Fences.

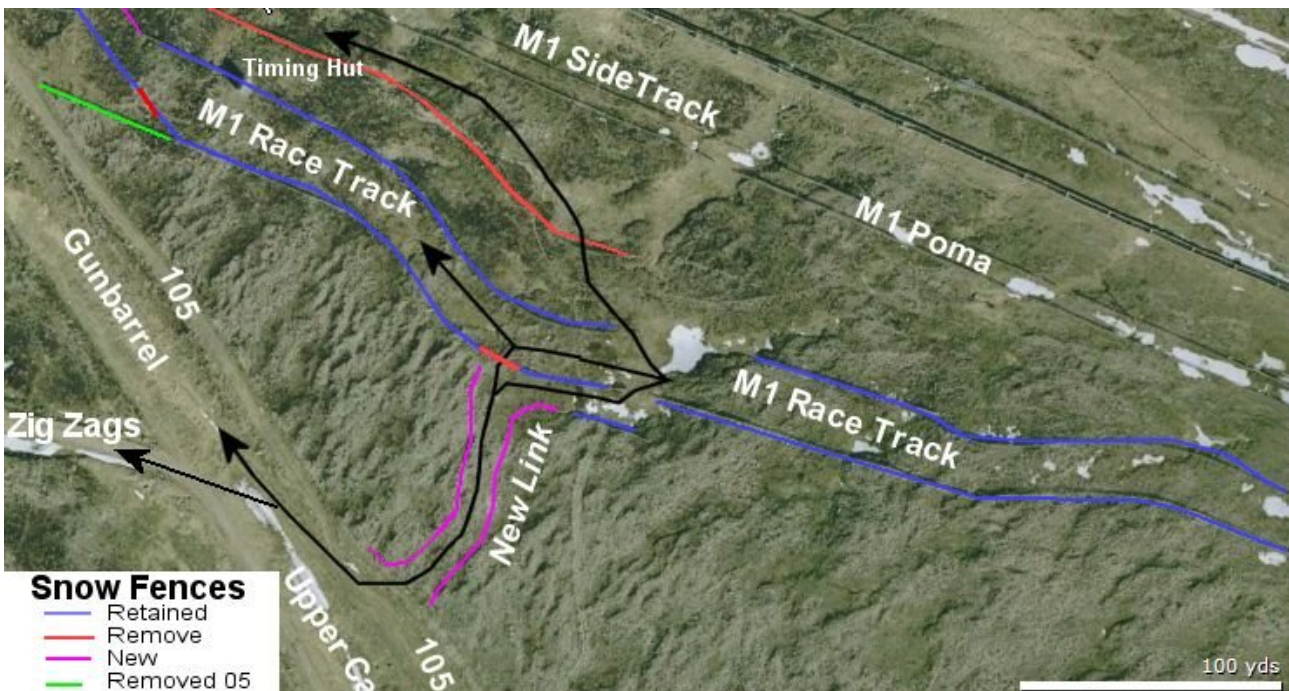
Illustration 1: Diagram showing suggested further snow fence alterations on the M1 including new higher level exit from the Race Track. The black arrows show possible descent routes with the new fence arrangements.

Therefore I suggest that the way to make the best use of the now improved snow holding of the Upper M1 is the provision of an alternative and higher exit from the M1 Race Track to a more snow sure route to the Middle. Given the Funicular blocks the route to the Lady, while fence lines going to skiers left seem more effective in this area (The Traverse shows this well), this exit should be to Coire Cas and be high enough up to allow all possible routes to the Middle to be accessed (the 105, Gunbarrel and the Zig Zags as well as the M1 itself) thus giving the widest range of possible options for a complete run, as indicated by the black arrows in illustration1:

To improve durability of this new link, the double fenced run should be fairly narrow. As we know fenced up-tracks tend to last longer than nearby wider fenced runs, and a short link doesn't need to be a wide piste.

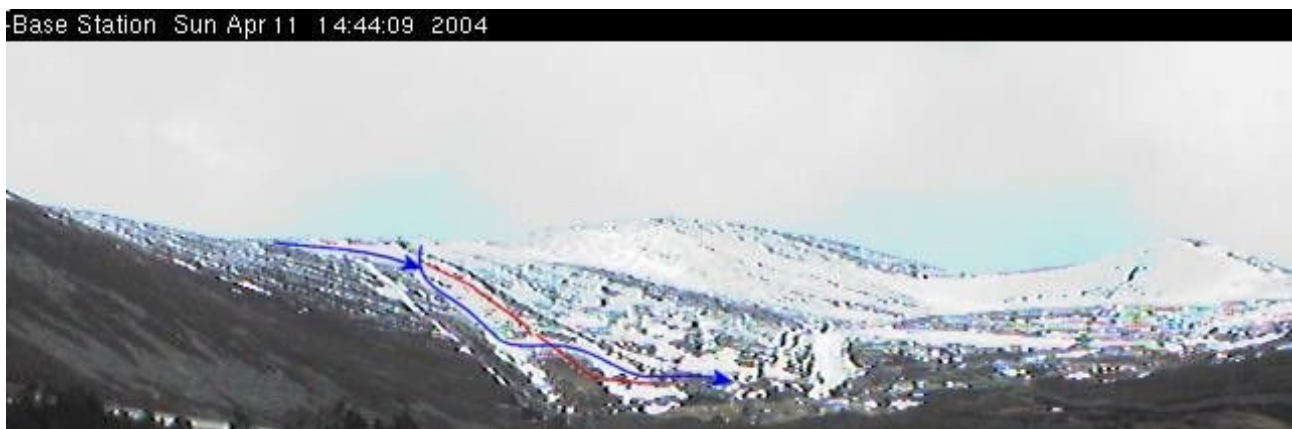
Illustration 2: White Lady - A run to nowhere or is it? The red line is the fencing, but the blue line shows a route to the M1 Poma via a natural snow hollow but is blocked by the fence.

The Funicular has magnified the problem, by increasing snow accumulation in a natural snow bed that would provide a much more durable route to the M1 Poma were it not dissected by an inappropriately placed snow fence:

The complete route down the Lady to the M1 Poma indicated by the blue arrow in the Web Cam image above follows an area of natural snow holding. This is shown up by the vegetation contrast in the aerial photograph (Illustration 3) of that section of the

With the existing fence configuration the fenced route crosses a raised ridge that is not a natural snow lie area, thus the fence configuration results in the Lady Run via the M1 Poma 'breaking' prematurely while there is still a good complete snow route via areas of natural snow holding (indicated by the blue arrow on both Illustration 2 and 3).

The Web Cam image in Illustration 2 shows a long break on the fenced link to the M1 Poma, yet the snow cover offers the potential of a good well covered run using the M1 Poma. Looking through the photo archive, it is not outrageous to suggest that the period of time where the White Lady is similarly 'unnecessarily broken' is likely to be measured not in days but weeks in some seasons.

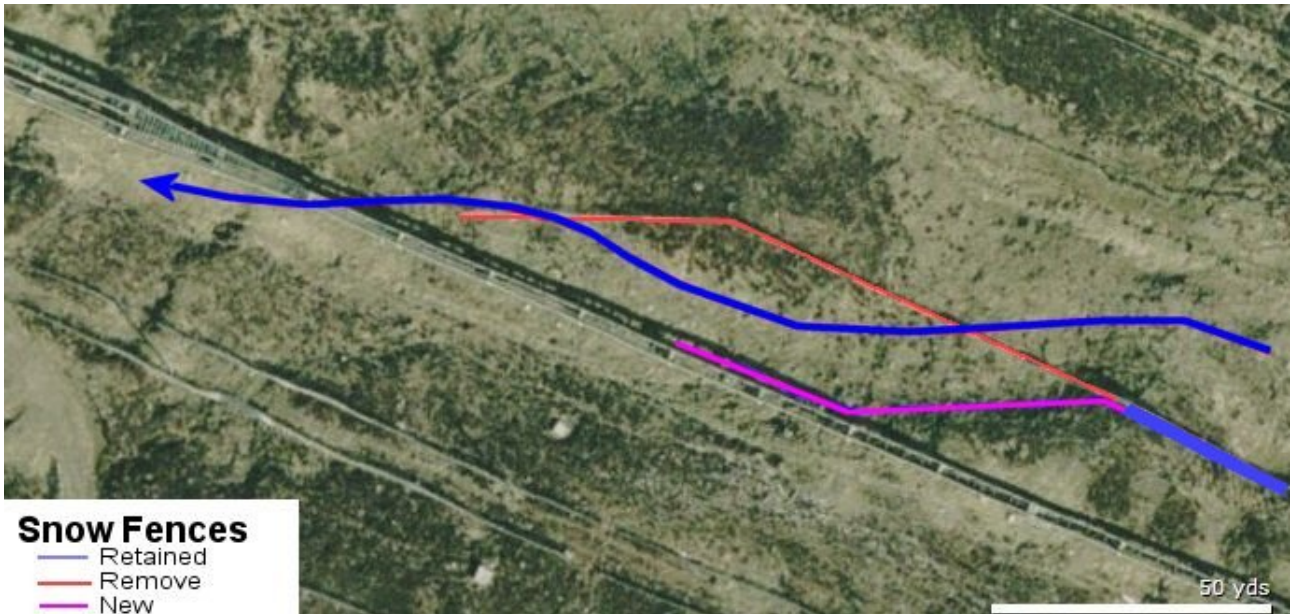
Illustration 3: The contrast in vegetation in this satellite photo shows up the natural snow bed (light colours) and how the existing fence blocks the natural run.
